HISTORIC AMERICAN BUILDINGS SURVEY
INVENTORY

2. NAME *Orrin Thompson Mansion*

DATE OR PERIOD *1832*
STYLE *Greek Revival*
ARCHITECT
BUILDER *Orrin Thompson*

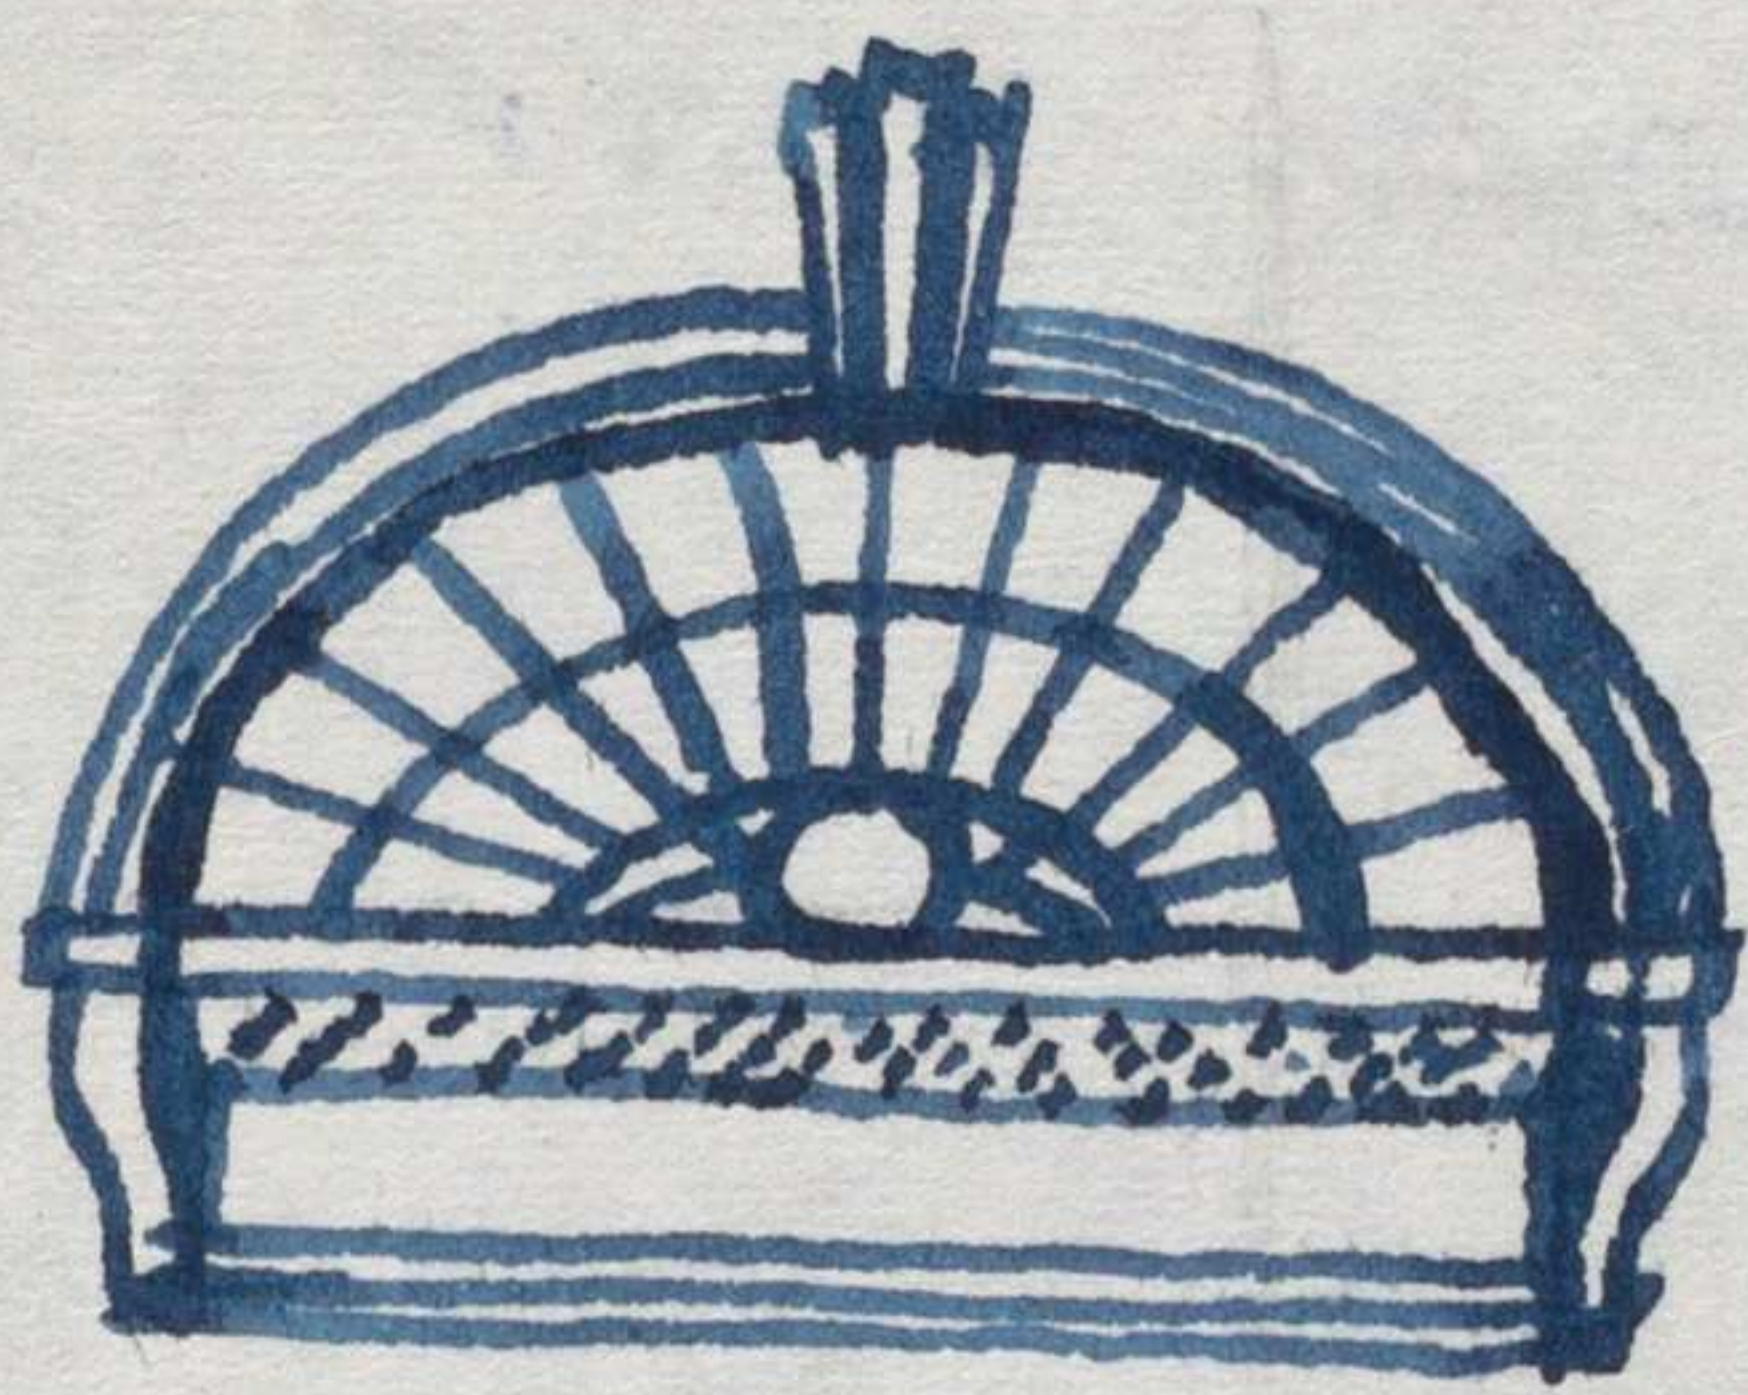
*ture over the plain pilasters support-
ing it. This feature was noted in at
least two other Enfield houses. The
leading in the pedimental window
also belongs to a form seen in half
a dozen other Enfield houses. To
the South and East extend old ells.*

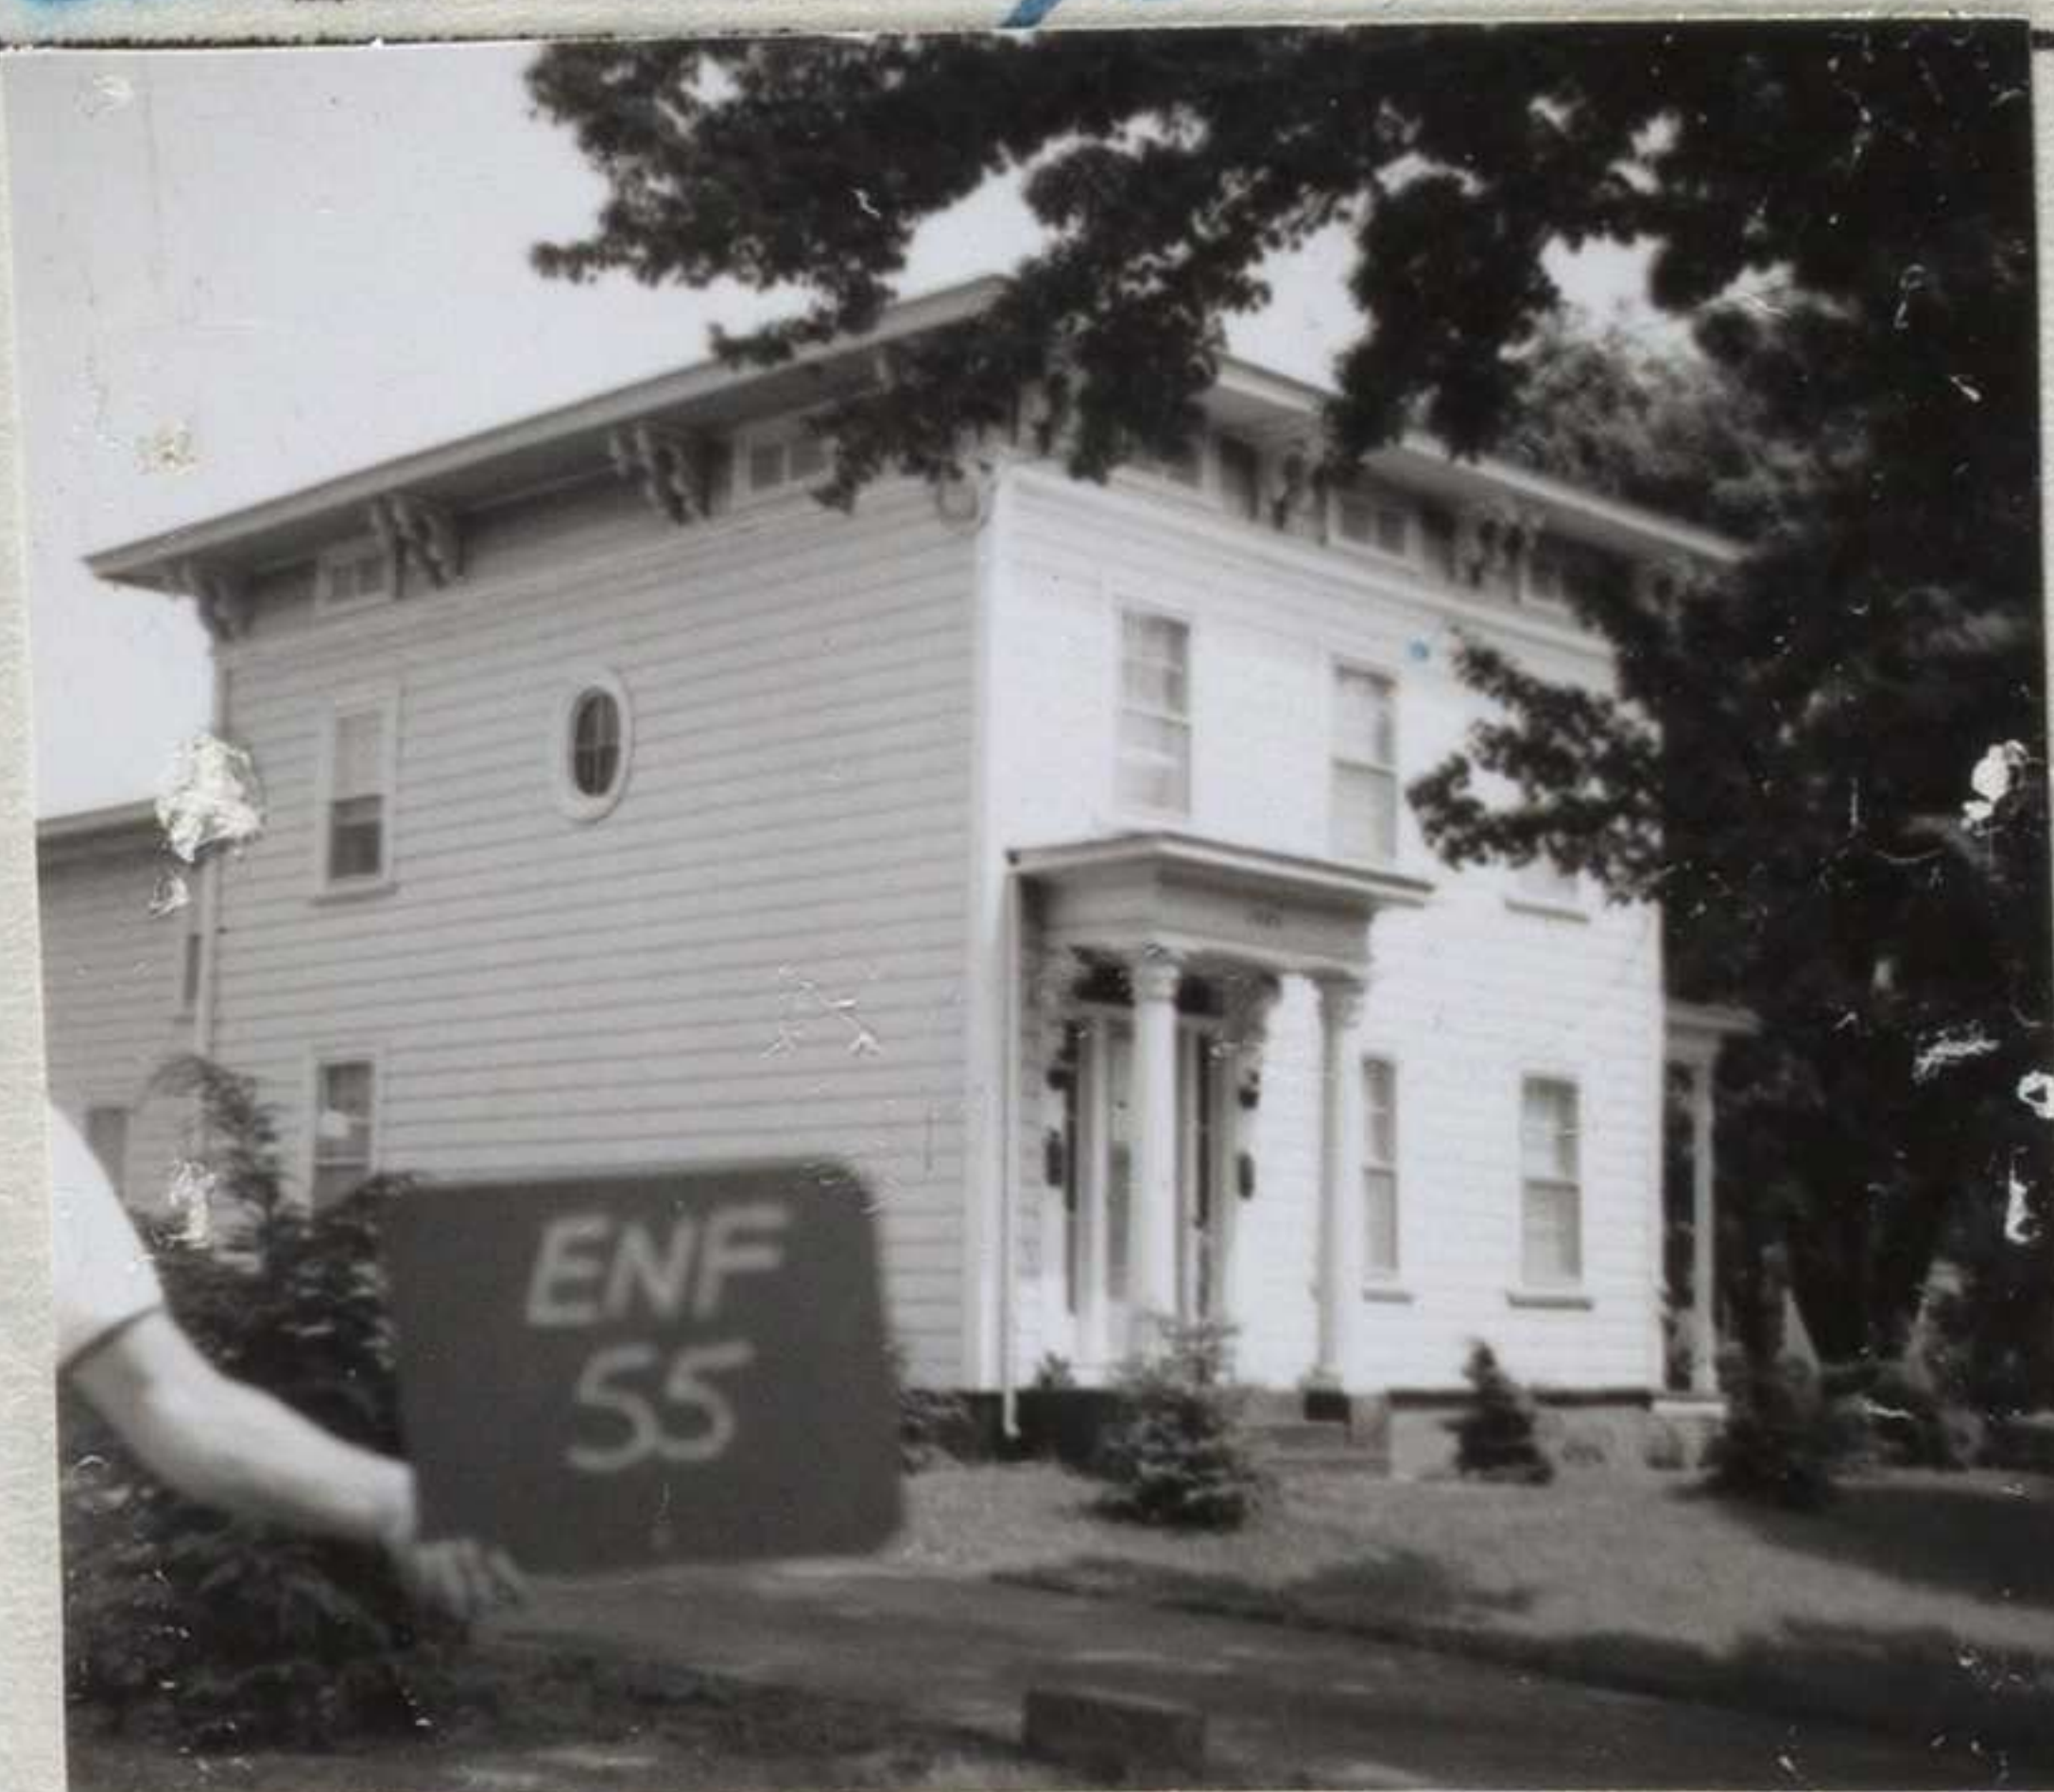
7. PHOTOGRAPH *Enf 55*

This fine house bears strikingly similar features to other houses of its period in town and may well have been designed or built by the same people. Built on a brownstone foundation the ell shaped, mansard roofed house has 3 bays on the front portion. The 1/2 size windows of the top story are shuttered and located between double brackets in the plain entablature. The fluted stylized columns have inventive capitals with a canthus bottom and Greek urn top. There is a side porch as well. To the side of the house there is an old well house with arbor lathing in two round head sections to a side and bracket held low pitched roof.

Endangered *No.* Interior *good.* Exterior *good*

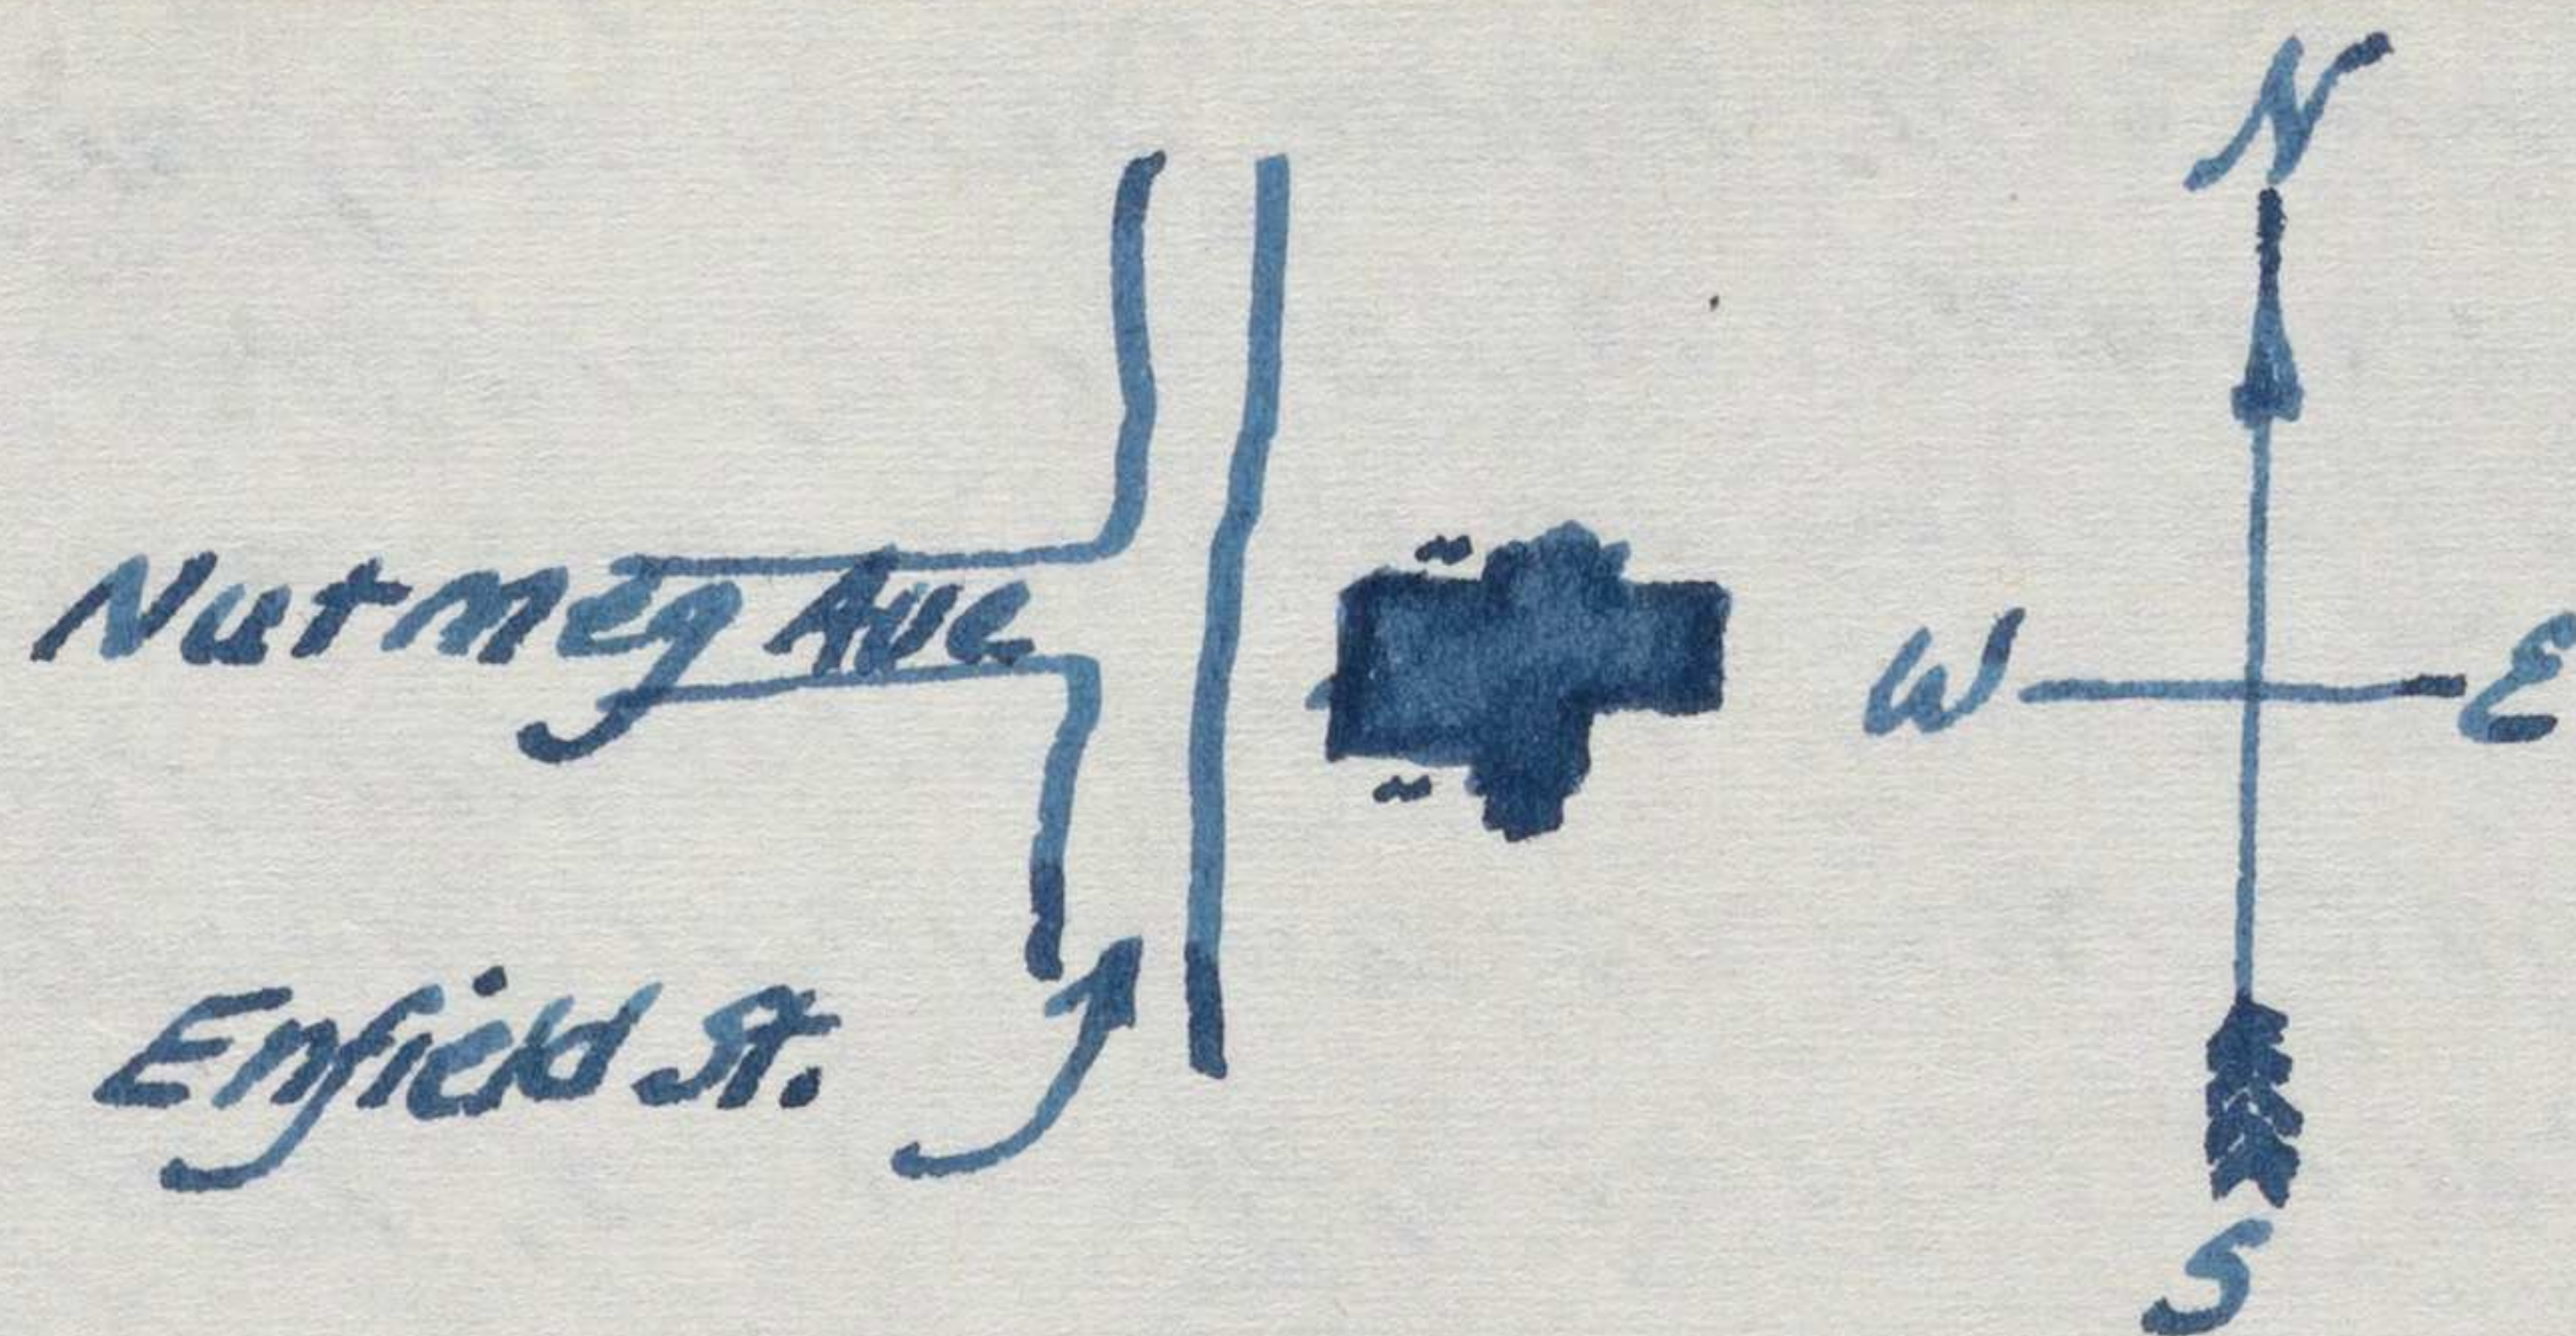
This fine 19th century mansion was built by Enfield's 2nd millionaire Col. Augustus G. Hazard whose powder discovery at Powder Hill was the impetus for the founding of the town Hazardville whose growth was largely due to the Civil War. The huge 2 1/2 story house is constructed in brown stucco covered brick. The French style moldings in stucco are echoed inside, as well.

The monster roof is supported on double brackets which enclose louvered half windows. The roof actually has one pediment caused by the fact that the cupola is so far off center. The over.

Endangered *No.* Interior *fair* Exterior *good.*

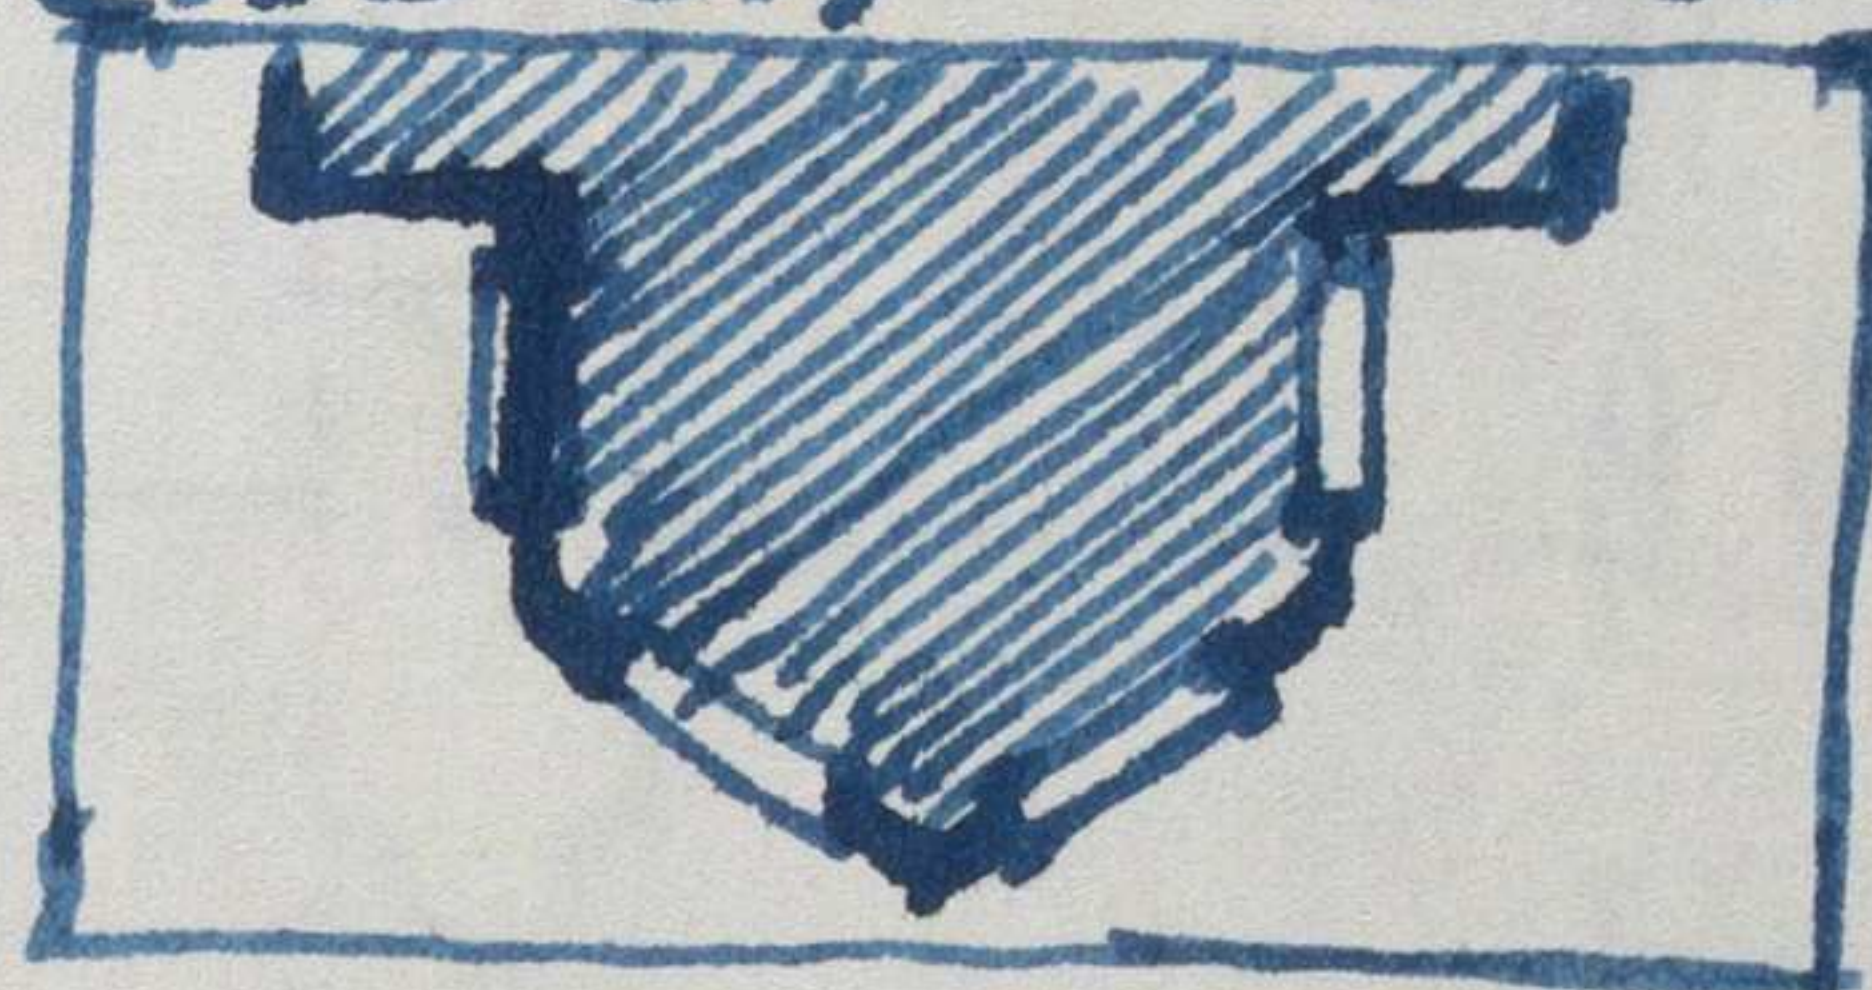
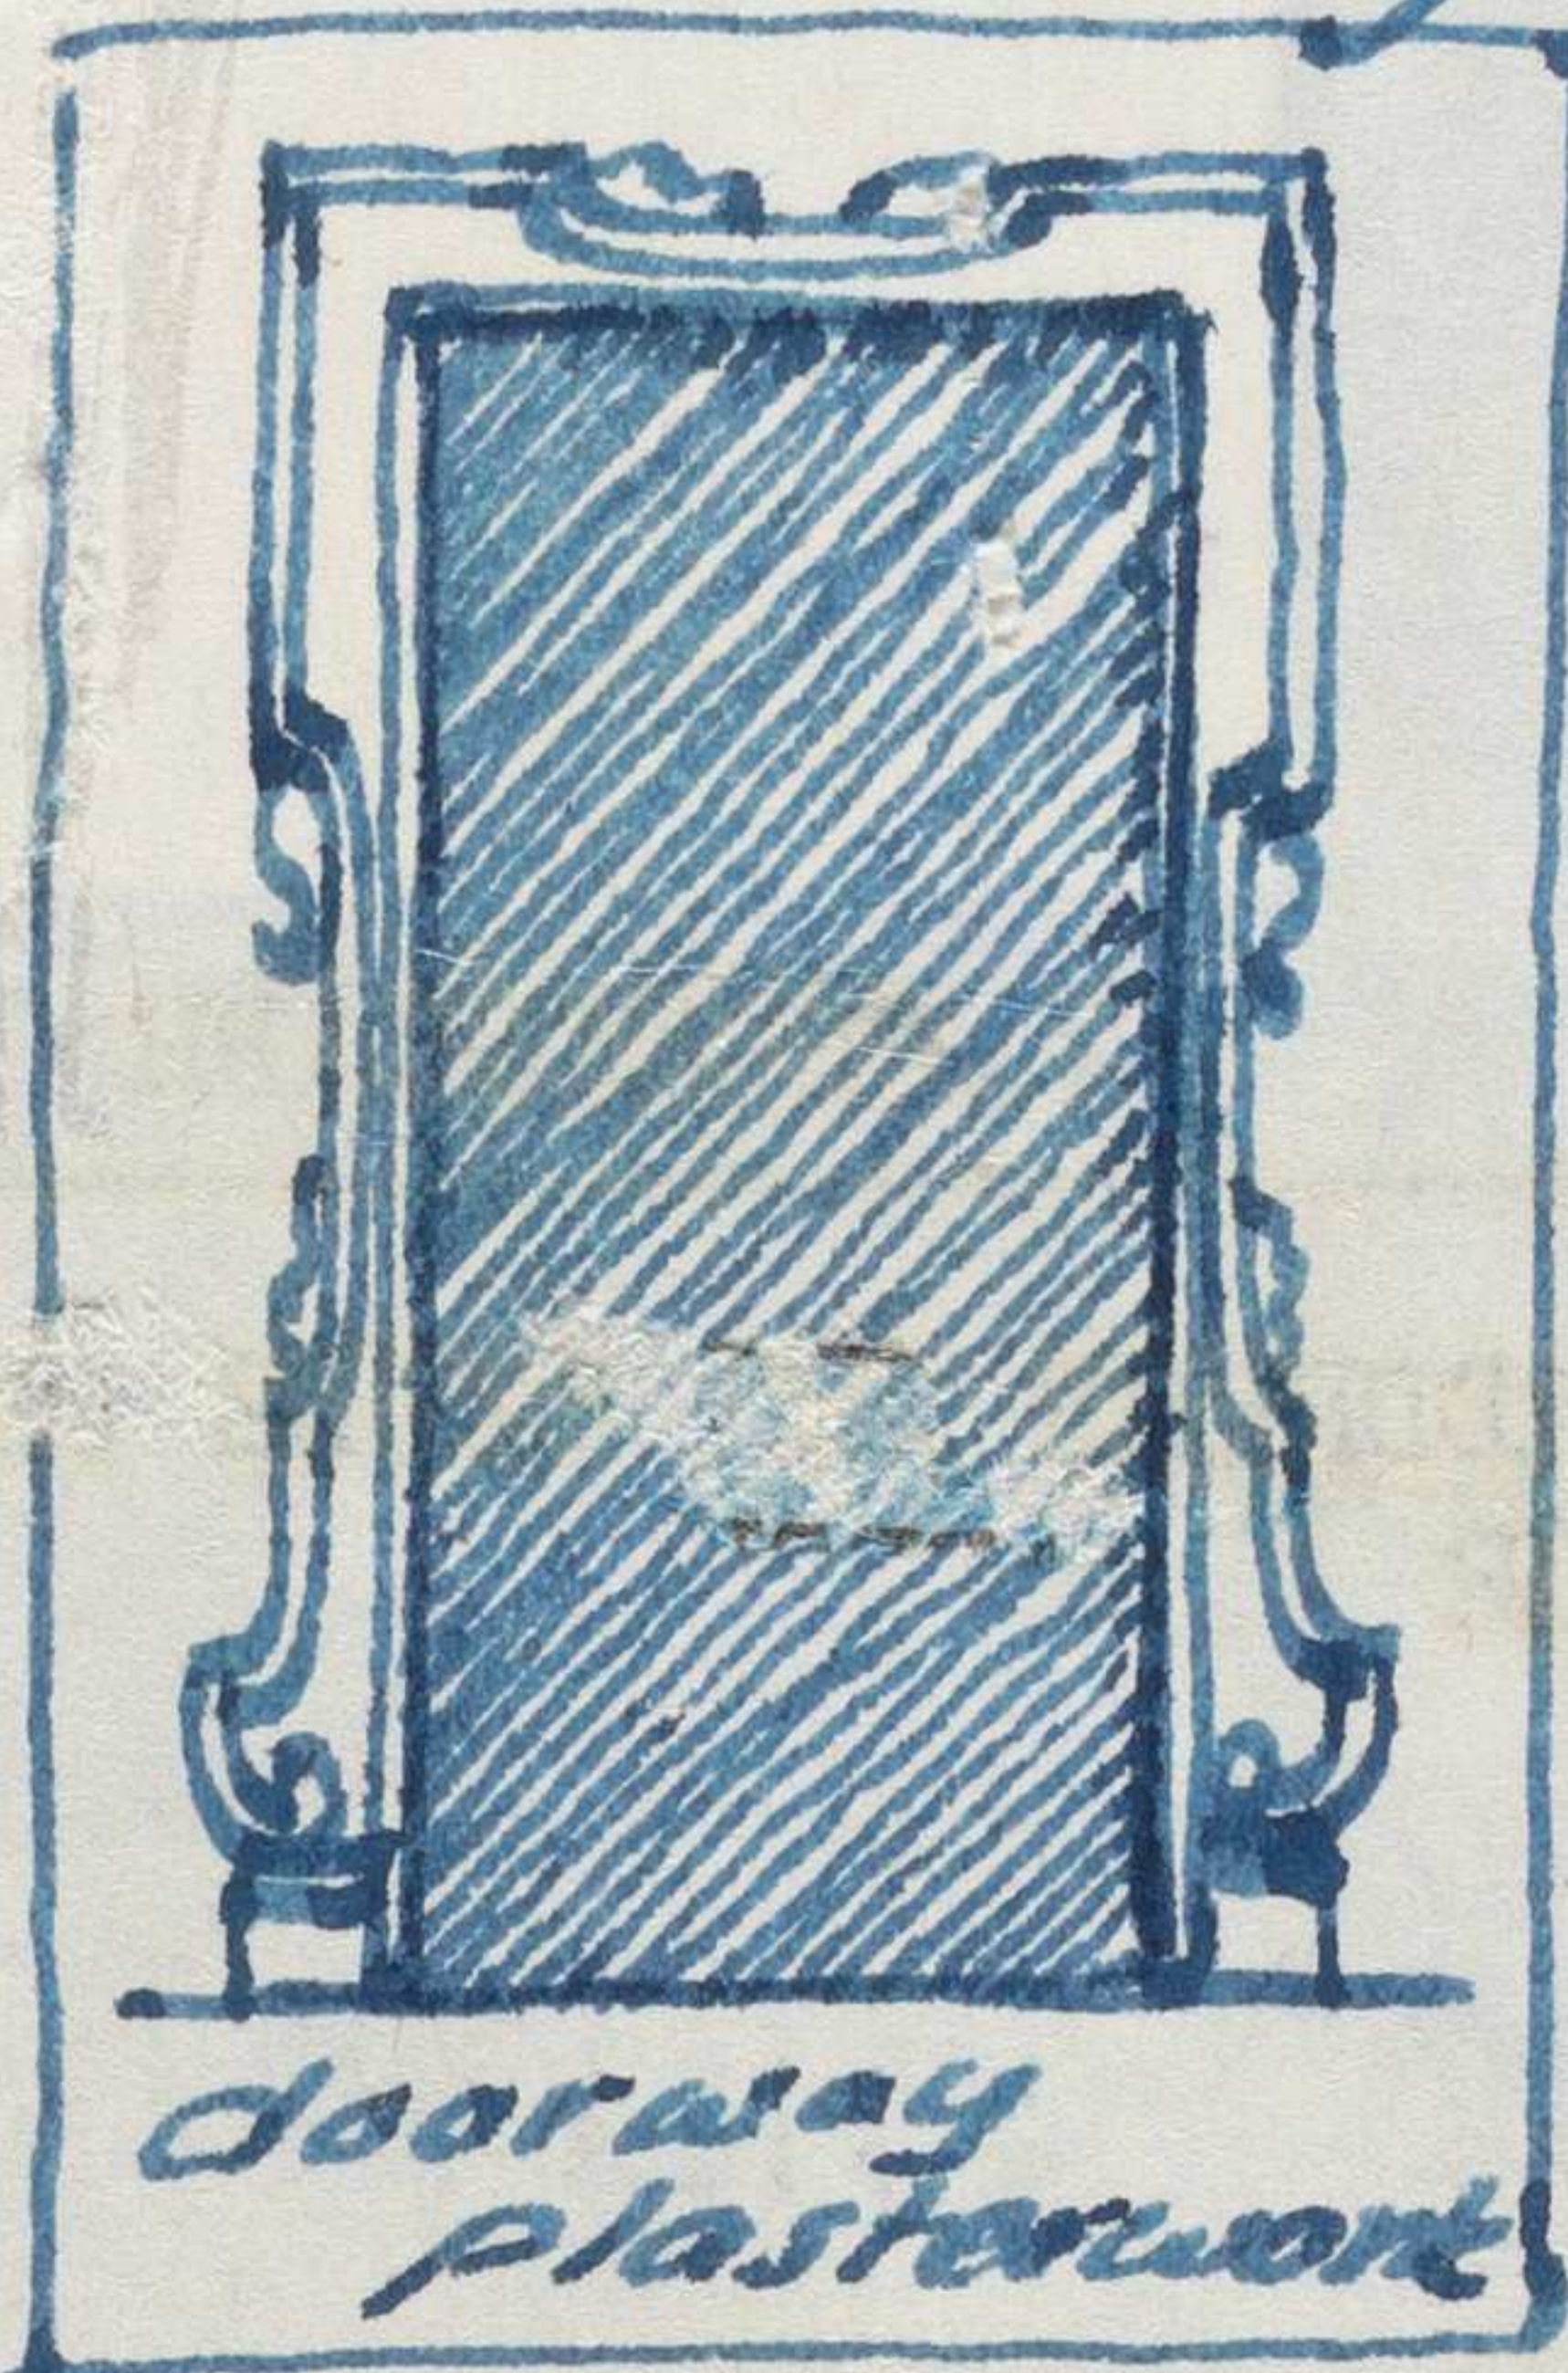
doorway
plasterwork

It is basically in good condition. There are magnificent alabaster marble mantles and fine plasterwork in the ceiling and moldings around windows and doorways.

The most magnificent feature of the interior is without doubt the the curving self-supported, three story staircase of carved mahogany which climbs past circular topped corner niches under the skylight formed by the cupula. The house is as a whole one of the best examples of 19th century houses in Connecticut.

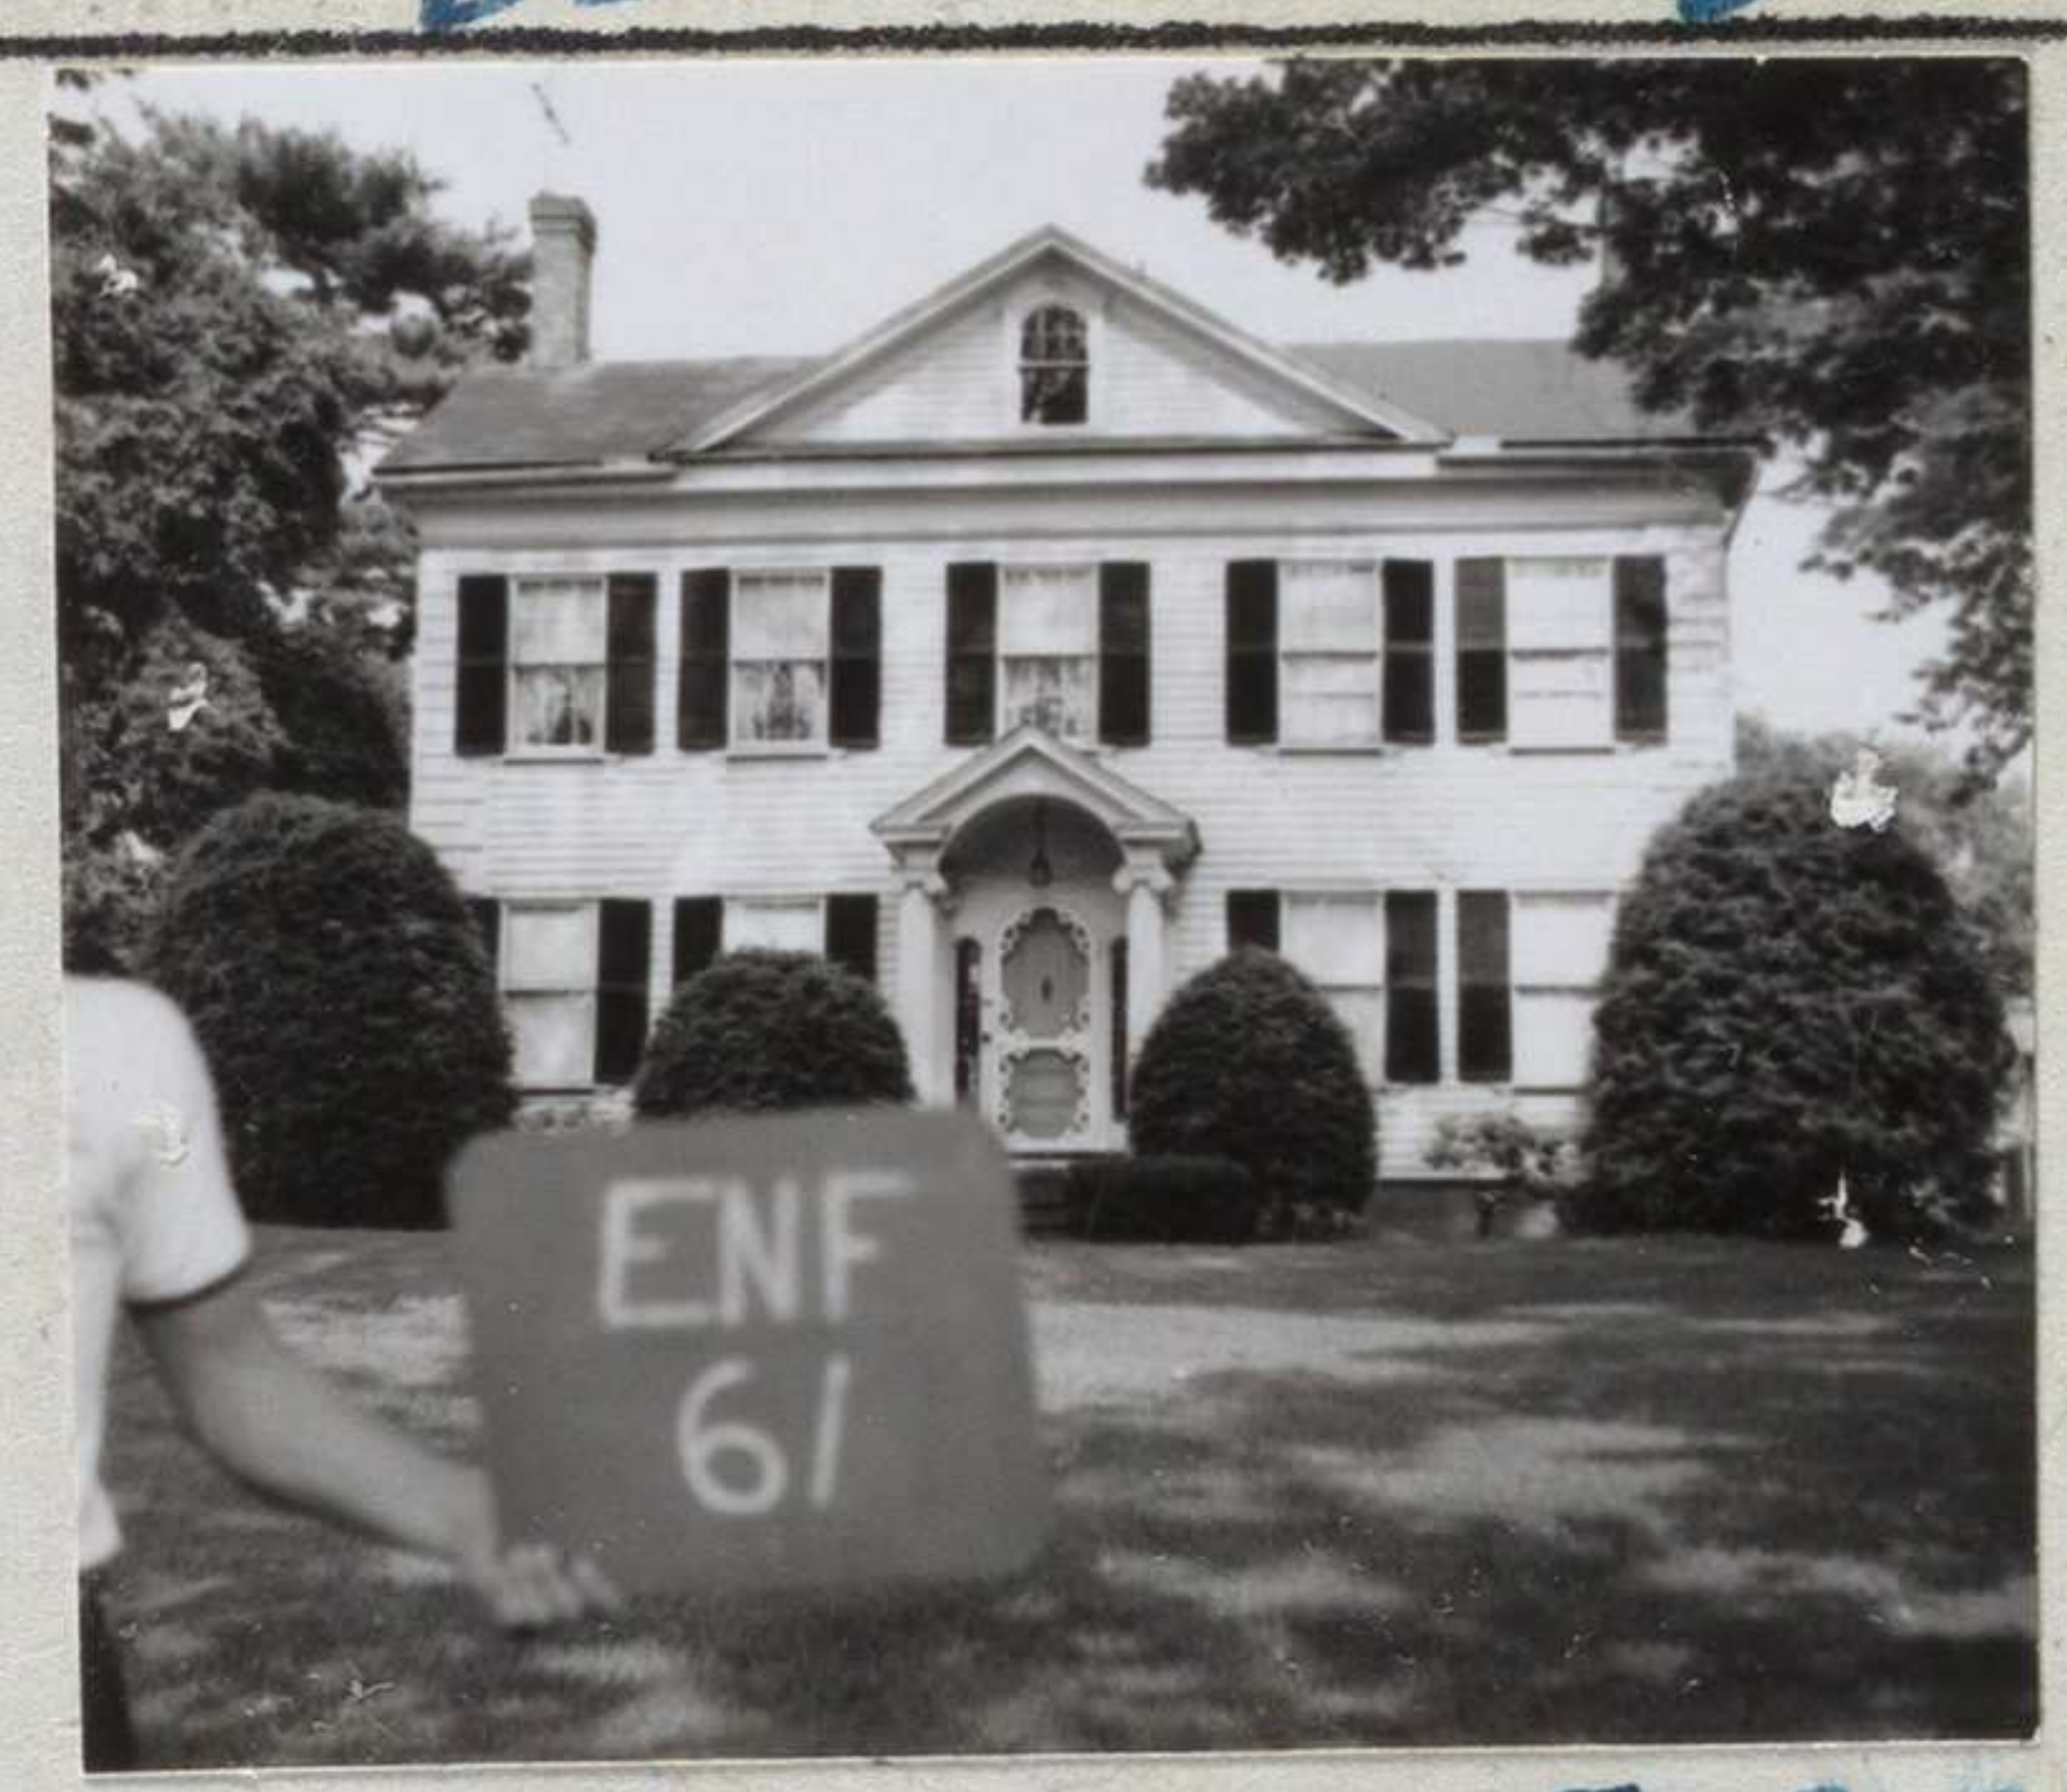
</div>		<div>7. PHOTOGRAPH <i>Enf 61</i>

<div>1. STATE <i>Ct</i> COUNTY <i>Hartford</i> TOWN <i>Enfield</i> VICINITY STREET NO. <i>1125 Enfield St</i> ORIGINAL OWNER? ORIGINAL USE <i>Residence</i> PRESENT OWNER? PRESENT USE <i>Residence</i> WALL CONSTRUCTION <i>clapboard</i> NO. OF STORIES <i>2</i></div>		<div>HISTORIC AMERICAN BUILDINGS SURVEY INVENTORY</div> <div>2. NAME DATE OR PERIOD <i>1820?</i> STYLE <i>many</i> ARCHITECT BUILDER</div> <div>3. FOR LIBRARY OF CONGRESS USE</div>	
<div>4. NOTABLE FEATURES, HISTORICAL SIGNIFICANCE AND DESCRIPTION <i>Built on a free brick foundation this five bay house seems to hold forms of many periods in its design. The house is of narrow depth with a shallow pitched roof and small end chimneys. The windows are of 6/6 panes and bear simple moldings with plain console supports under the sills. A pediment ornamented with a segmental window as rises above the middle three bays. The doorway is perhaps the strangest feature. The door itself and its side-lights are semi-circular topped. Strange ionic columns also decorate this doorway and a dreadful 20's canopy caps the odd assemblage. The corners of the facade are decorated with alternating quoin stones.</i></div> <div>OPEN TO PUBLIC <i>No</i></div>

<div>5. PHYSICAL CONDITION OF STRUCTURE Endangered <i>No.</i> Interior <i>fair</i> Exterior <i>fair</i></div>			
<div>6. LOCATION MAP (Plan Optional)
